REPORT  
ON  
THE FLOODS OF THE MOIRA RIVER,  
AT  
BELLEVILLE, ONT.

APRIL, 1920.

WALTER J. FRANCIS & COMPANY  
CONSULTING ENGINEERS  
MONTREAL.

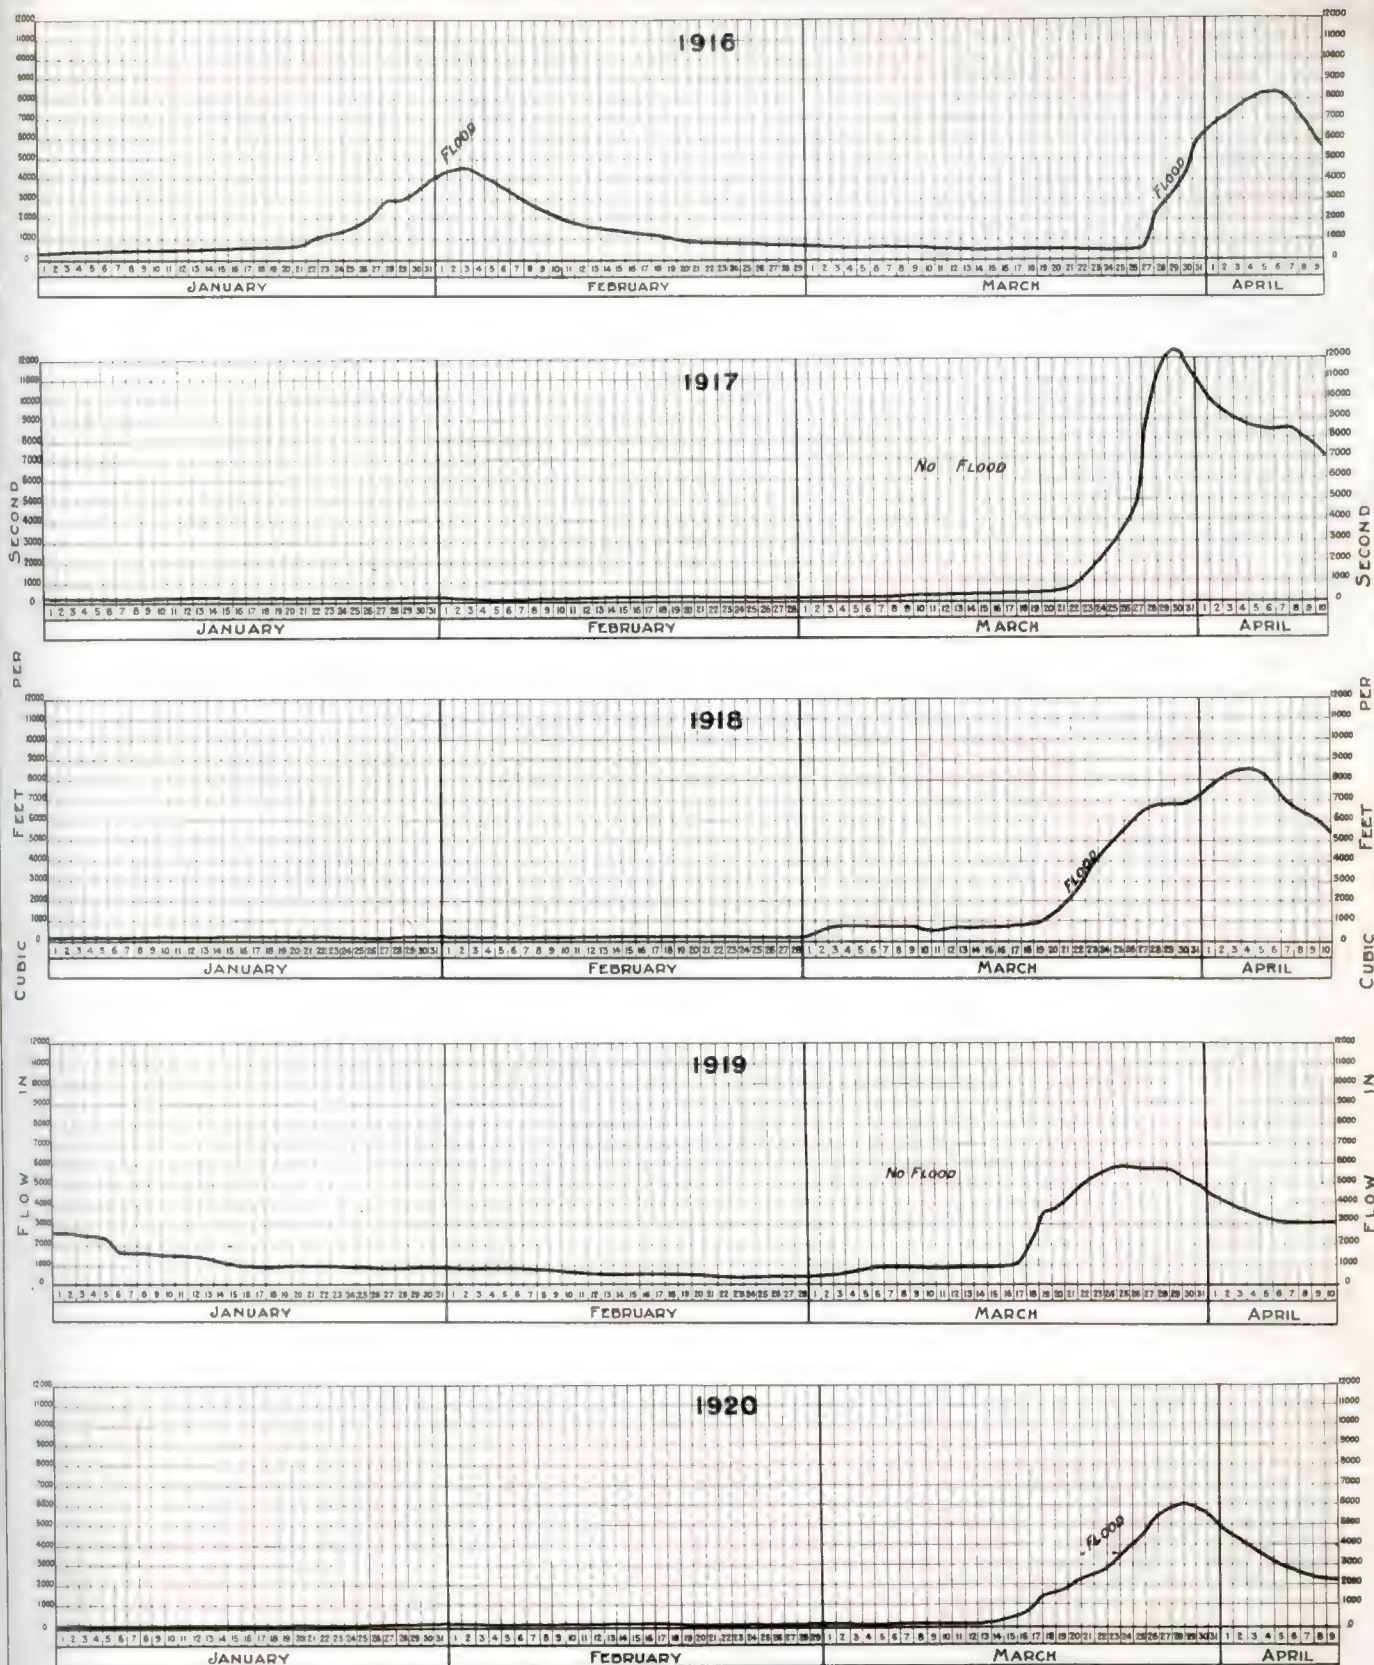
Note - The above diagrams are based on Gauge readings obtained at Foxboro, Ont.

**MOIRA RIVER, BELLEVILLE, ONT.**  
 DISCHARGE IN CUBIC FEET PER SECOND  
 JANUARY 1<sup>ST</sup> TO APRIL 10<sup>TH</sup> OF THE YEARS  
 1916 TO 1920

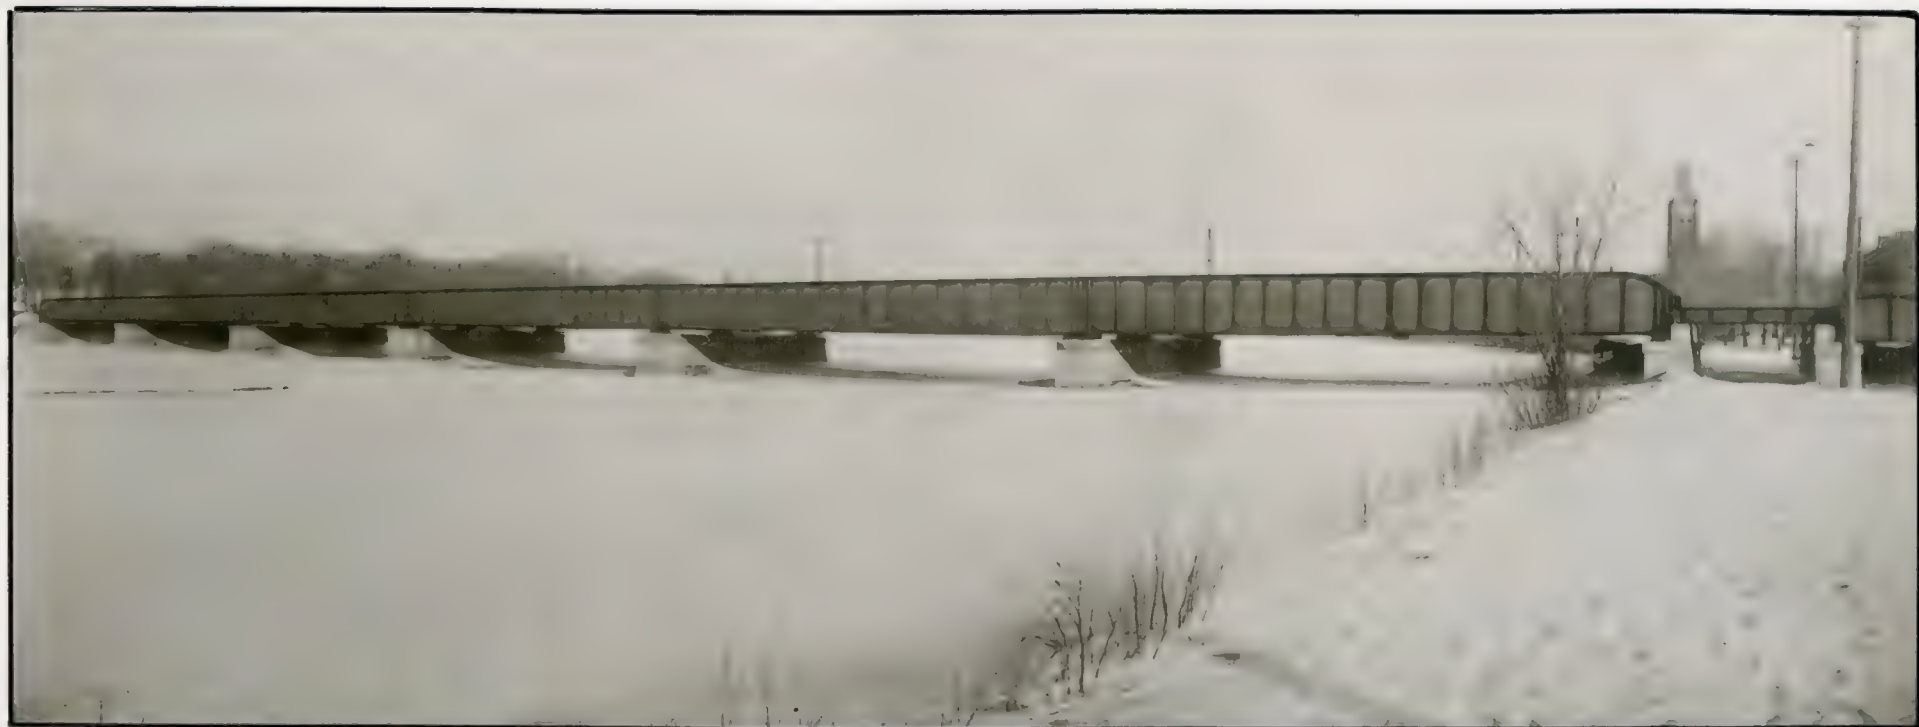
Photograph No. 5.

Downstream Side of Railway Bridge,  
Looking North-West from Dyke.

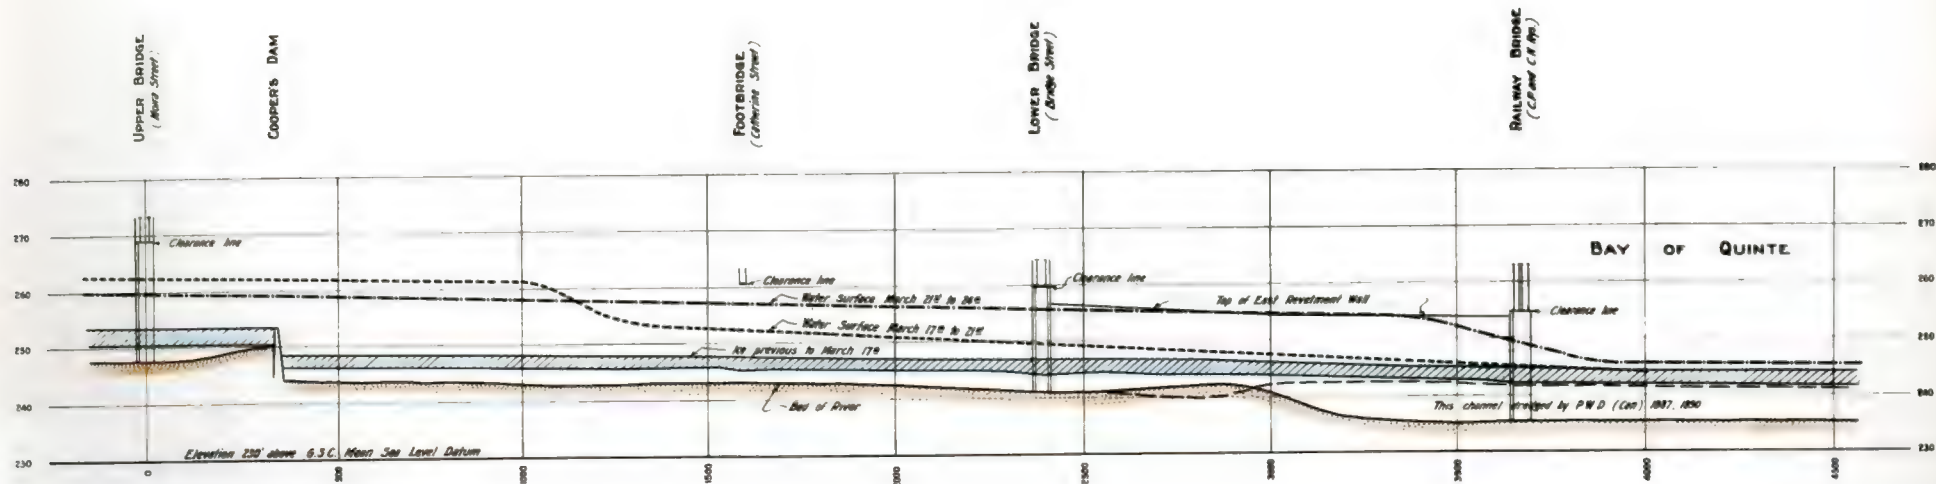
**MOIRA RIVER, BELLEVILLE, ONT.**  
**PROFILE OF RIVER THROUGH BELLEVILLE**  
 SHOWING VARYING CONDITIONS DURING  
**MARCH 1920**

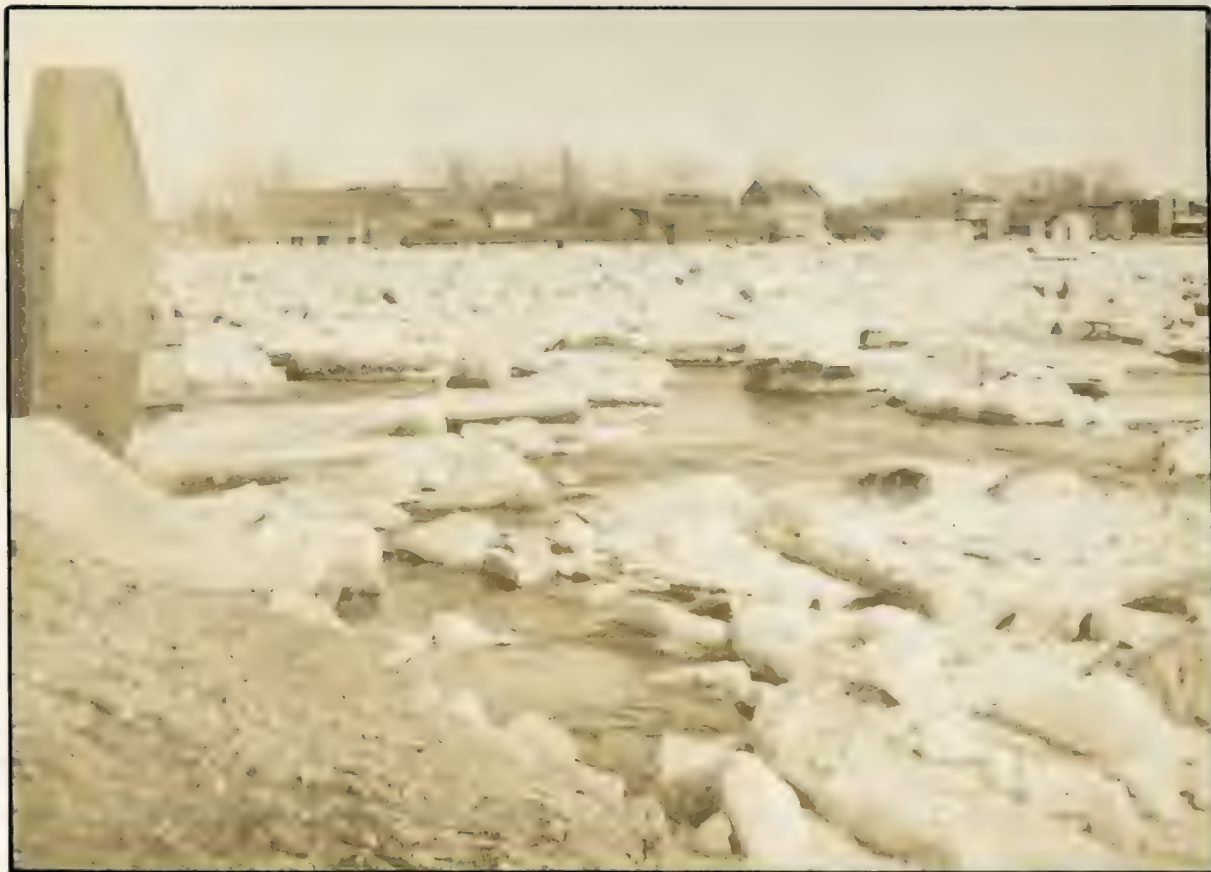
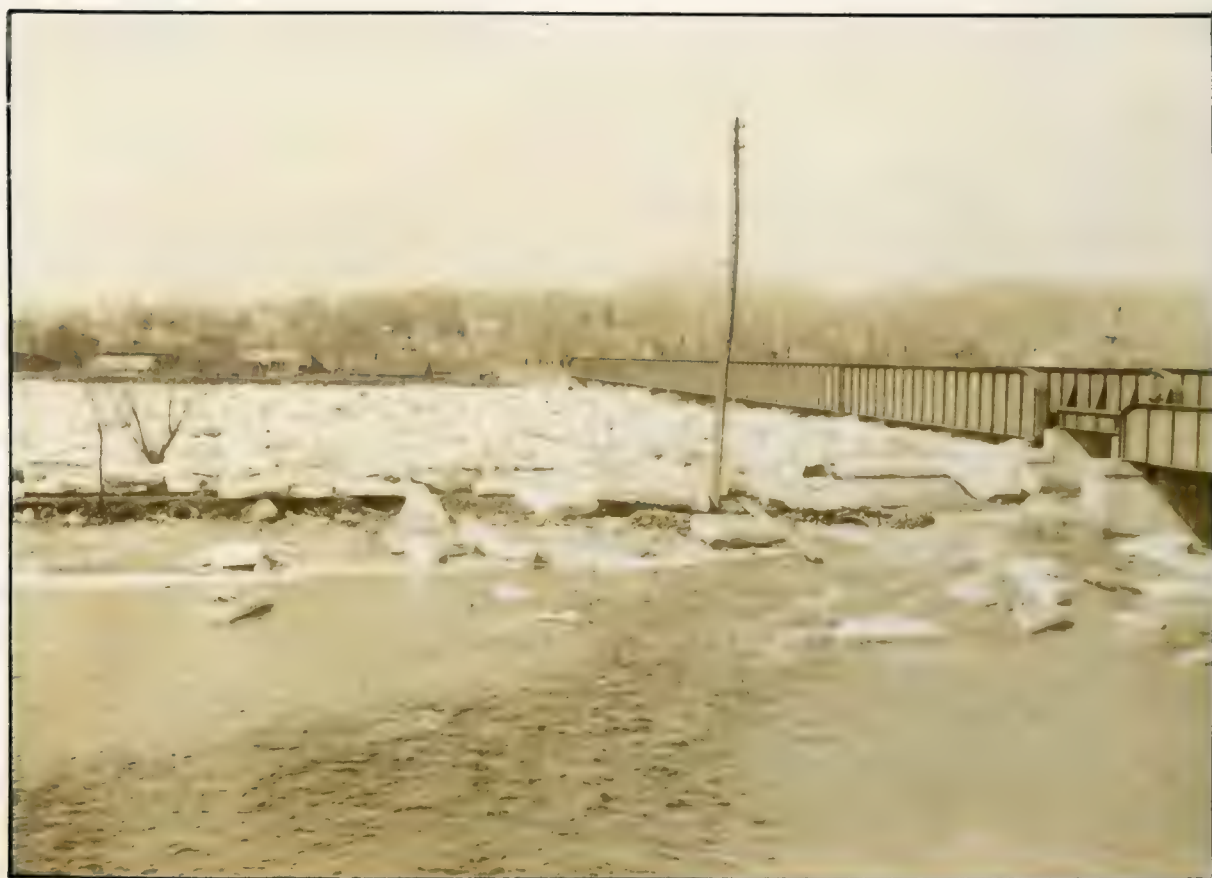
Photograph No. 14.

Downstream Side of Railway Bridge,  
Looking North-West from Roblin's Boat-house.

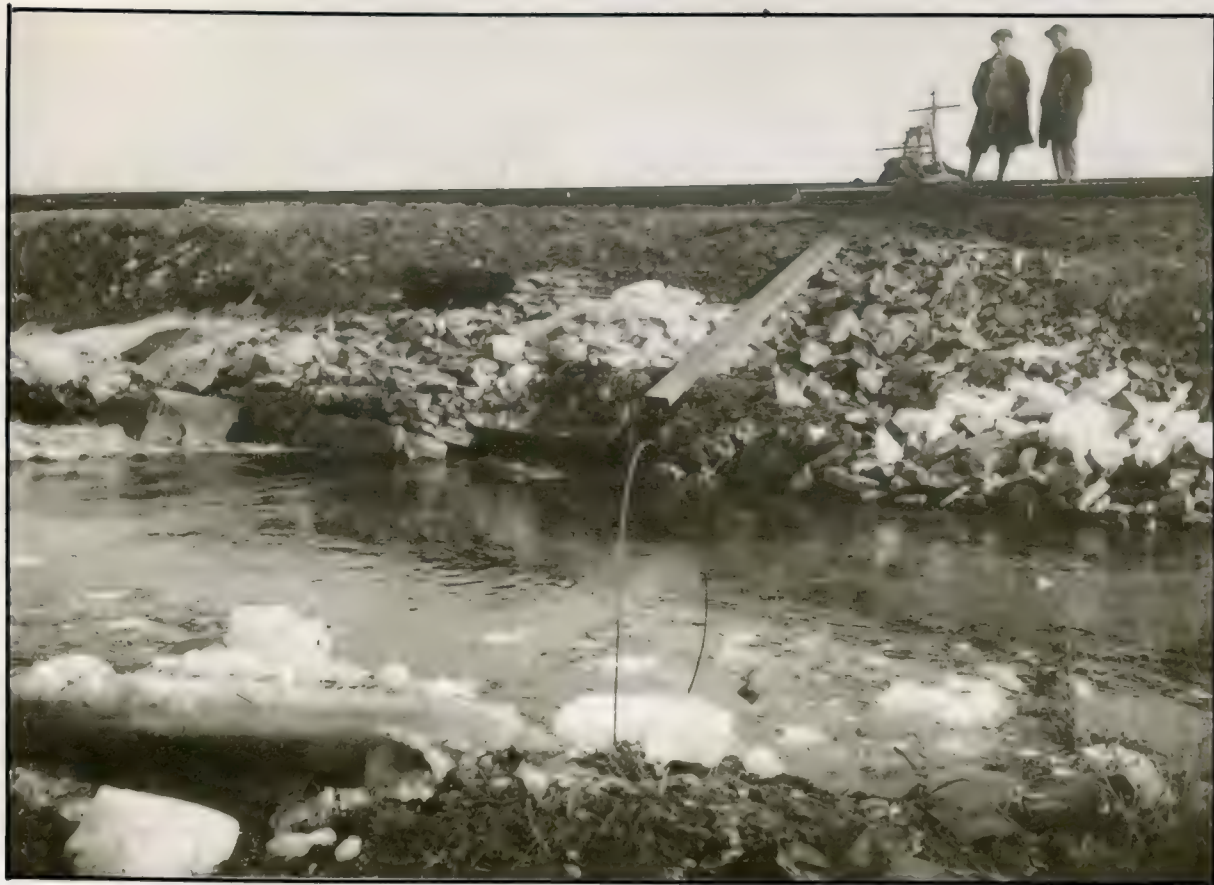
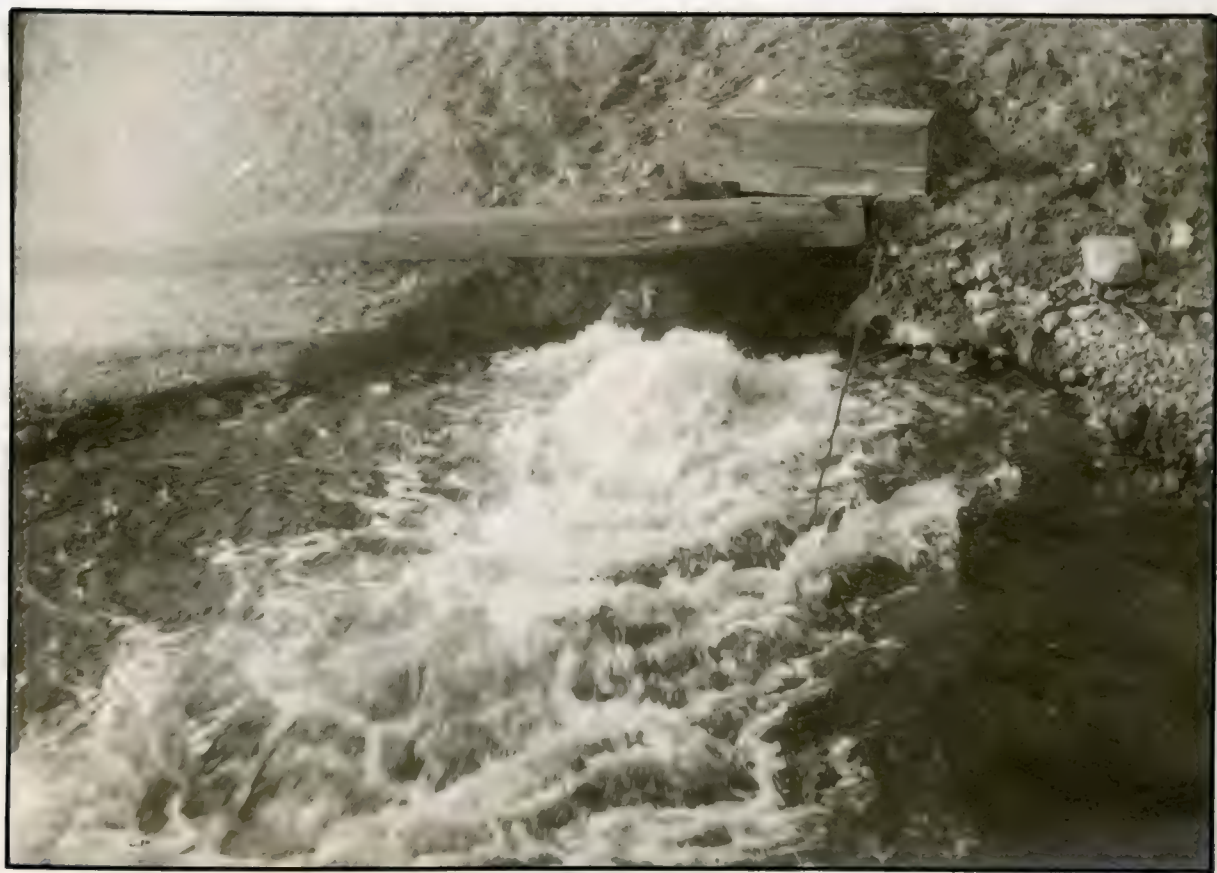
View of South End, Looking North.

1. That the culvert immediately west of the Railway Bridge be replaced by a larger one with an opening about 8 feet wide and 5 feet high, and also that an additional culvert with an opening about 10 feet wide and 5 feet high should be constructed in the neighbourhood of the James Street crossing, together with a suitable outlet to the bay, south of the tracks.
2. That the heavy surface ice be prevented from forming in an area extending 100 feet north and 400 feet south of the Railway Bridge, by employing one or two men to devote the whole of their time during the winter months to breaking up the surface ice as it forms.
3. That the City of Belleville be approached with the request to participate in the cost of such work of keeping an open waterway.

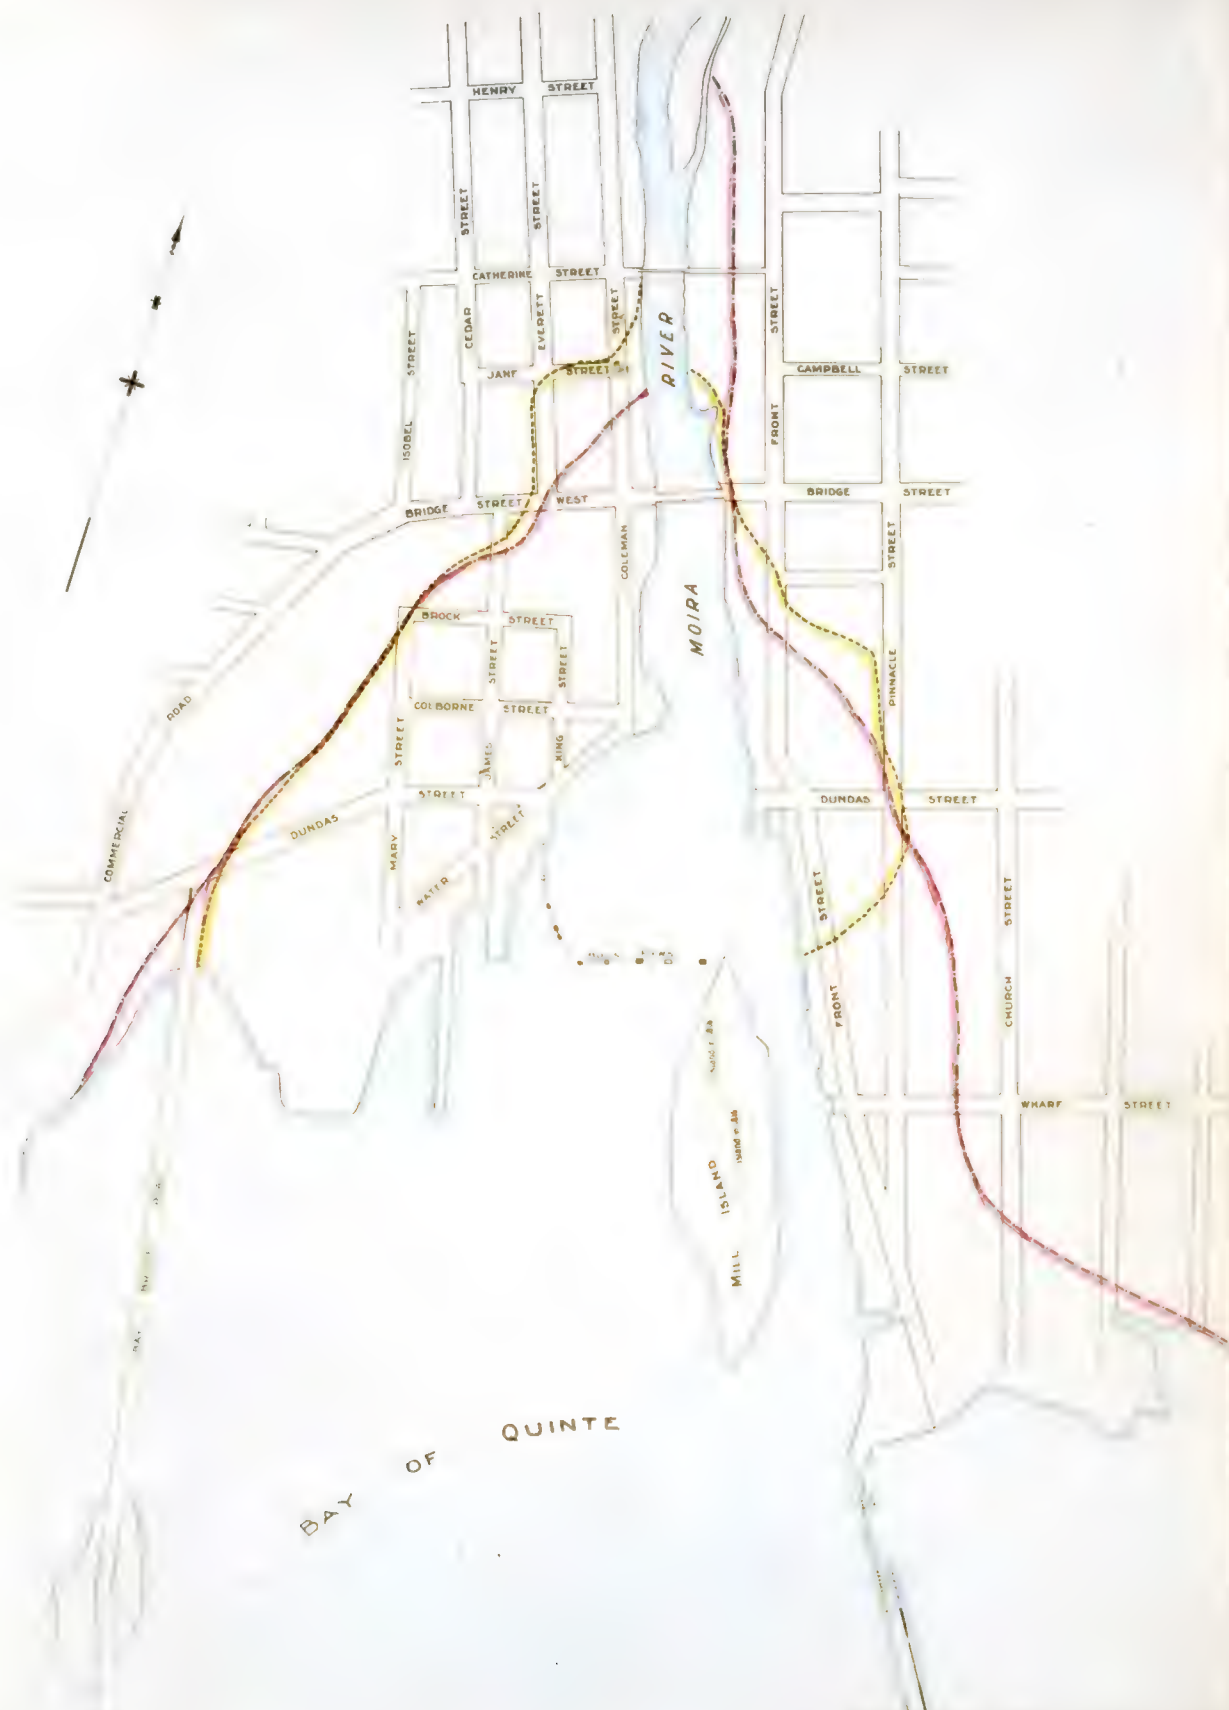
Limit of Surface Flooding in March 1886 shows this  
 " " " " " January 1891 " "

MOIRA RIVER, BELLEVILLE, ONT.  
PLAN SHOWING LIMITS OF FLOODING  
IN YEARS 1886 & 1891

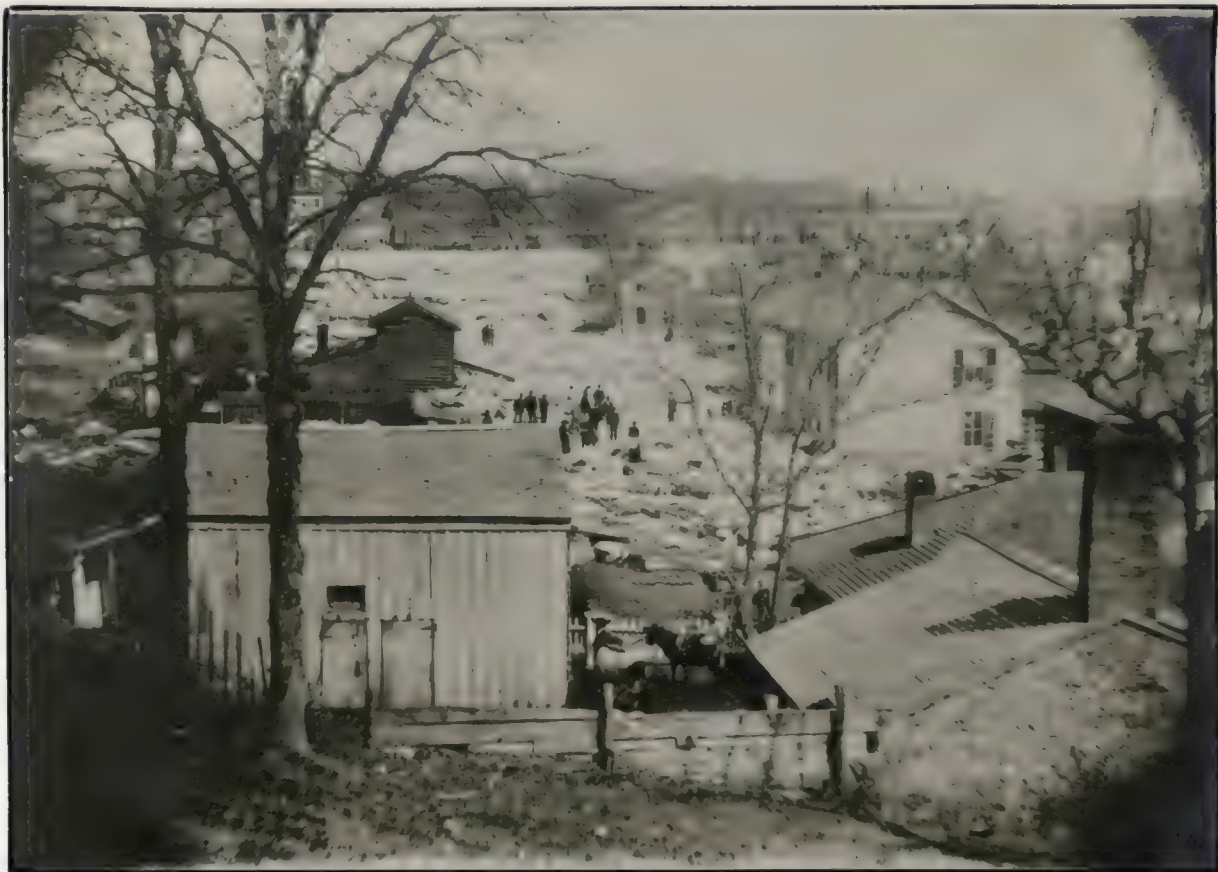
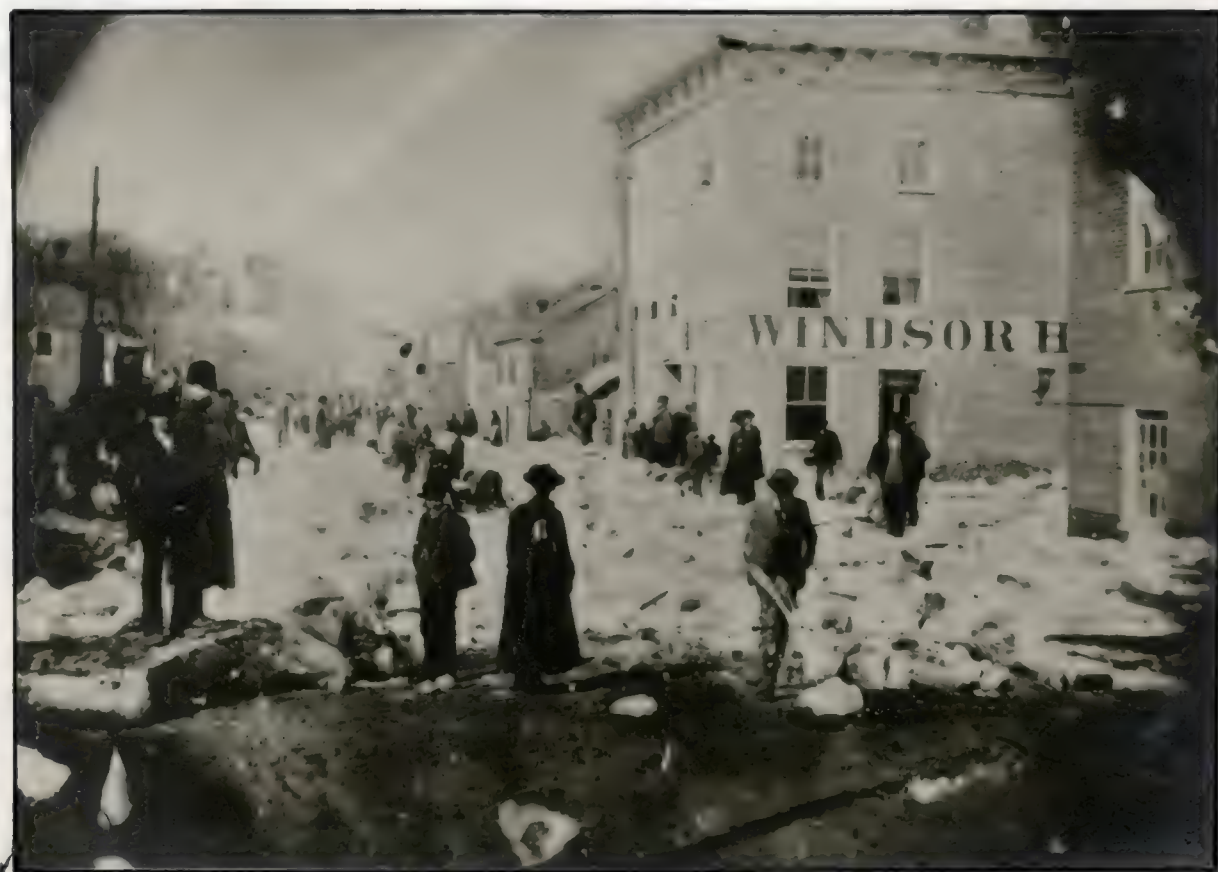
View showing Flood Conditions on Brock Street,

View showing Flood Conditions on Bridge Street, West.
